# Post-Earthquake Assessment of an Educational Masonry Building After the 2019 Albania Earthquake

## Research article

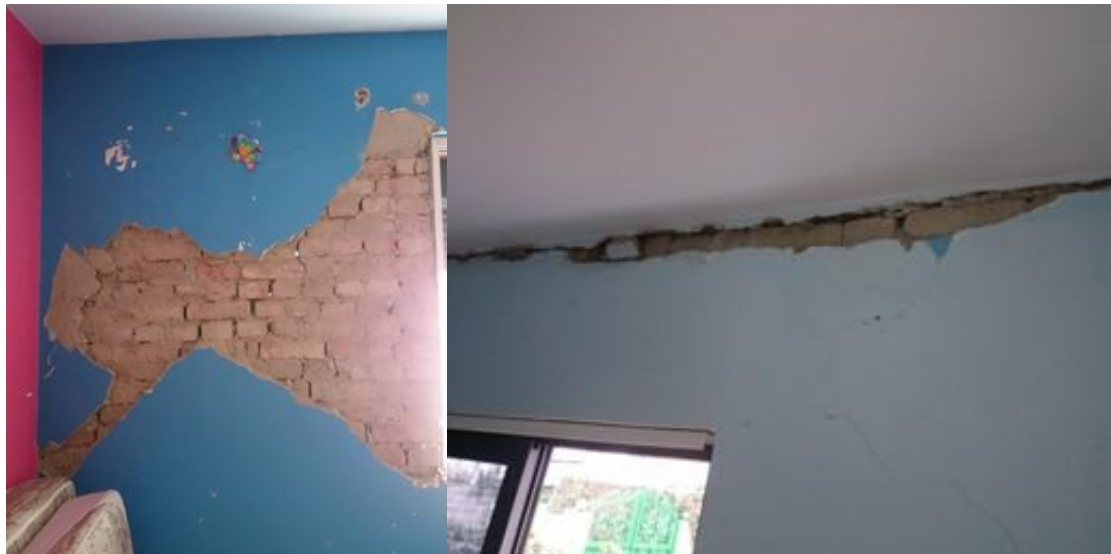
Figure 5. a) In-plane failure of masonry, b) Lack of proper anchorage.

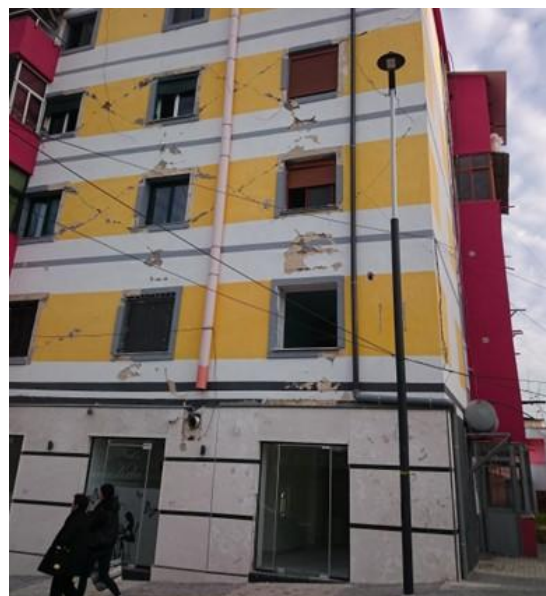
In many of the damaged structures, in-plane shear failures were frequently seen, often manifested as double-diagonal shear cracks. In numerous older structures across Albania, excessive shear or bending forces led to significant in-plane damage (Figure 5a). In the absence of proper anchorage, exterior walls acted as cantilevers along the height of the buildings, leading to failures in numerous structures (Figure 5b). In masonry facades with numerous window openings, shear failures were frequently observed in spandrels and short piers (Figure 6). Additional damage observed in unreinforced masonry (URM) buildings was attributed to the absence of rigid diaphragm action (Figure 7a). Failures resulting from poor material quality were also prevalent in many masonry buildings (Figure 7b).

Figure 6. In-plane shear failure of masonry piers.

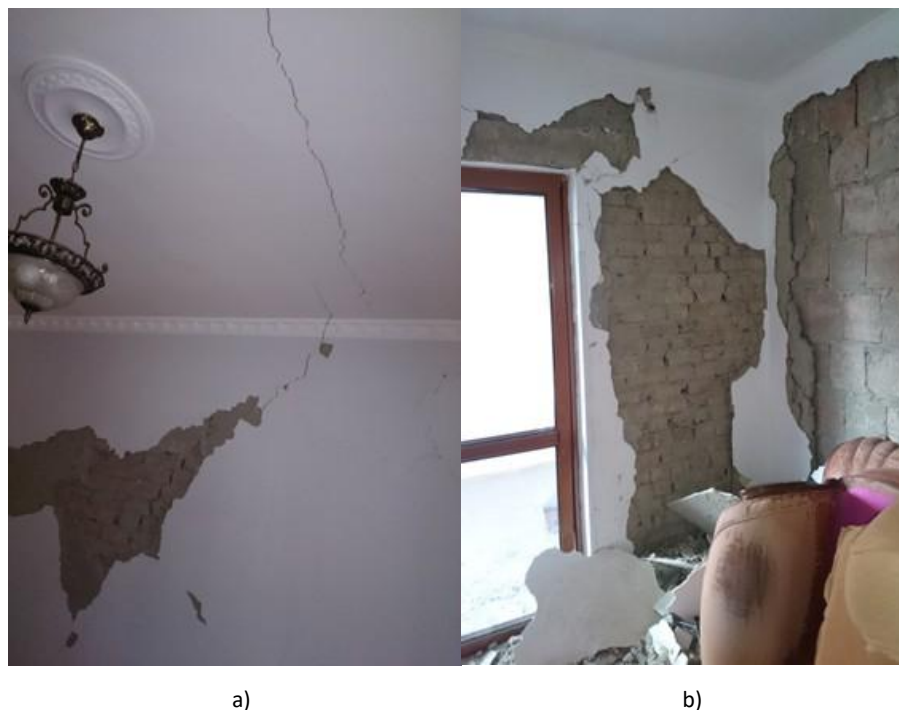
Figure 7. a) Diaphragm-related failures, b) Poor material and substandard workmanship-related failures.

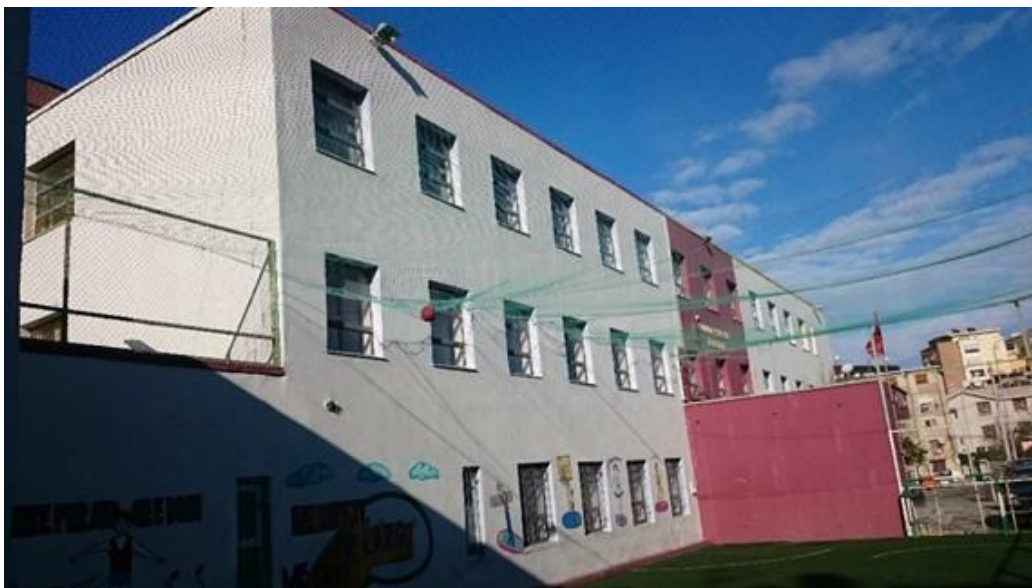
Figure 9. The main building under investigation.

The original design documents obtained from the Central Technical Archive of Construction depicted a highly regular, symmetrical load-bearing masonry structural system. However, the post-earthquake field survey revealed that the building had indeed been subjected to a severe, unauthorised structural modification during its service life. Specifically, occupants had demolished a load-bearing masonry wall on the upper floor to expand the spatial capacity of a classroom. In unreinforced masonry structures, the continuous vertical alignment of load-bearing elements is paramount for the safe transfer of shear and gravitational forces to the foundation.

The removal of an upper-story wall creates a severe vertical mass and stiffness irregularity. This structural discontinuity interrupts the established load path, forcing the seismic shear forces to redistribute through adjacent spandrels and transferring highly concentrated, eccentric loads onto the underlying ground-story masonry piers. During the 2019 Durrës earthquake, this localised structural deficit manifested exactly where the theoretical stress concentration occurred: a pronounced 45-degree diagonal shear crack formed in the wall directly supporting the modified bay. Representative original ground and first-floor plans of the school blocks, retrieved from the archive, are presented in Figures 11 and 12, respectively.

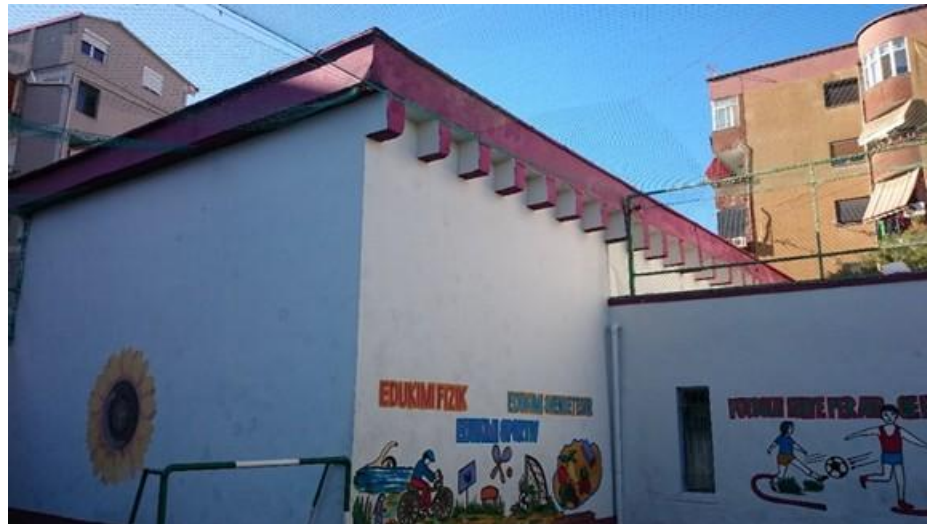
Figure 10. Sport hall.

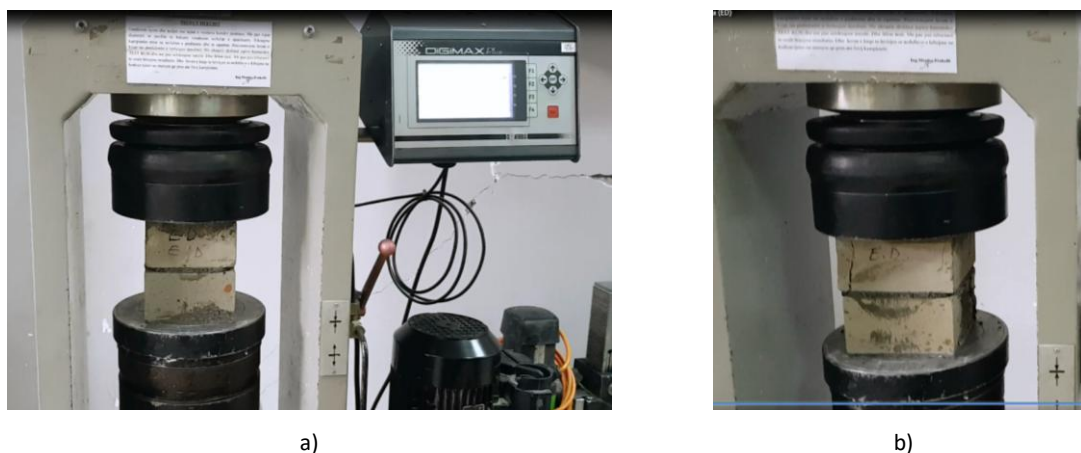
The two buildings are composed of two main elements: load-bearing walls and floor diaphragms. The walls are relatively stiff and include various openings, while the diaphragms are generally formed using RC floors. The construction materials used for these buildings include calcium silicate solid bricks. Calcium silicate solid bricks bonded with cementitious mortar define the load-bearing elements of this structure. In-situ extraction involved the removal of masonry prisms directly from the non-critical structural walls. These samples were transported to the laboratory and subjected to uniaxial compressive testing to determine the mean compressive strength and the corresponding coefficient of variation (Figure 13).

Figure 13. a) Sample during testing, b) Sample after testing.

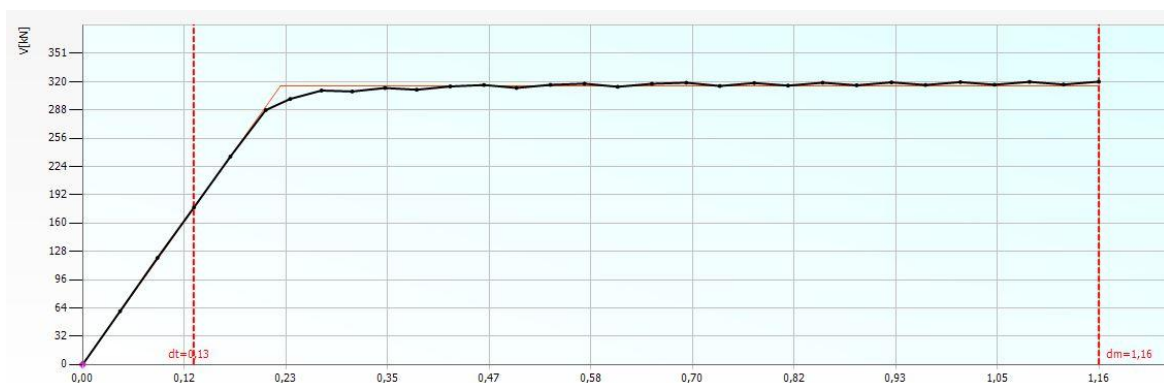
Damage levels corresponding to each limit state defined in Eurocode 8 were identified for the sports hall under lateral loading in the x- (Figure 17) and y- directions (Figure 18).

Figure 17. Pushover curve for x- direction (sports hall).
